Manhole Inspection Summary

Manhole # S37GG_015MH

Location Address: **400 OLIVER ST**

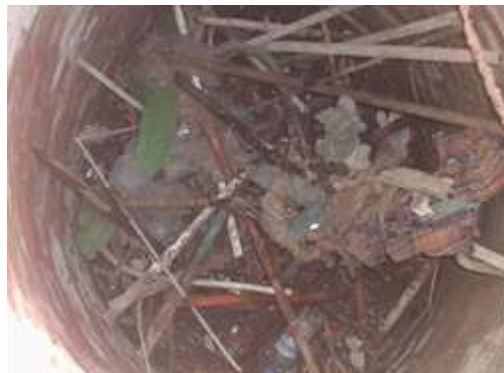
Top View

Corroded steps. Channel debris.

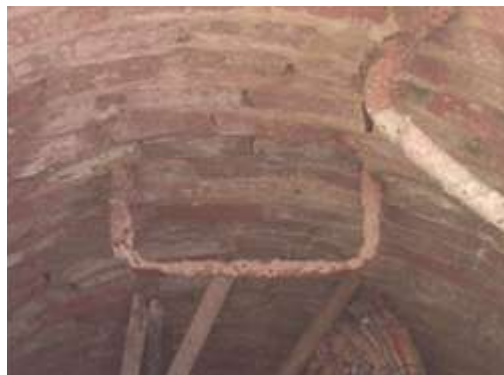
Defect

Corbel deterioration and infiltration. Barrel infiltration.

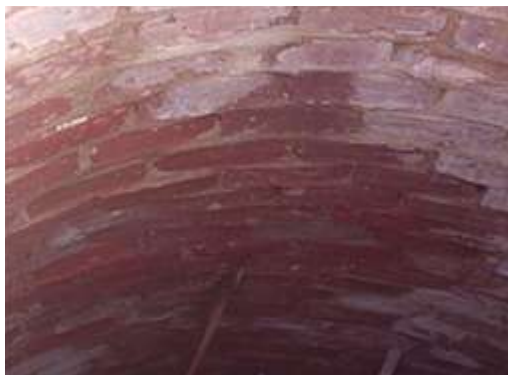
Defect

Corbel infiltration.

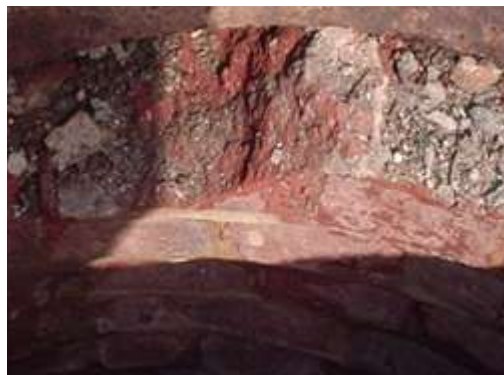
Defect

Frame leaks. Frame offset. Adjustment deterioration and infiltration.

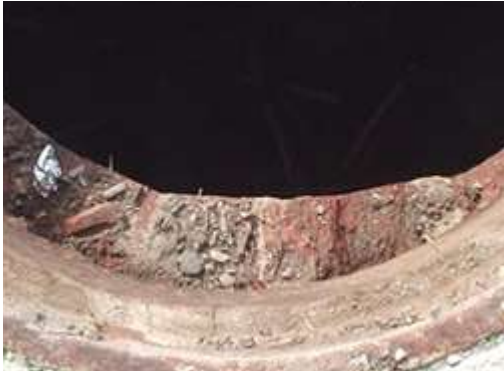
Defect

Frame leaks. Frame offset. Adjustment deterioration and infiltration.

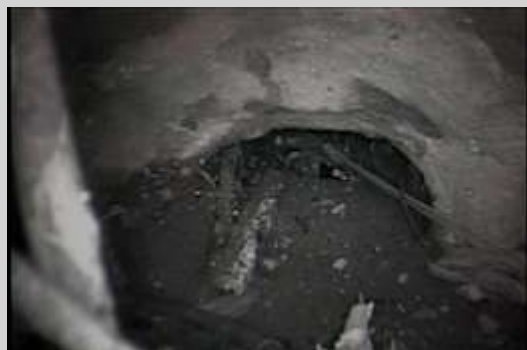
Pipe Out @ 12 O'Clock

Deposits: ☐ None ☒ **Mud** ☐ Sludge ☒ **Debris** ☐ Grease

Infiltration: **Evidence**
